THE DESERT DAMPWOOD TERMITE (ISOPTERA: KALOTERMITIDAE) AS A STRUCTURAL PEST IN THE COLORADO DESERT OF SOUTHERN CALIFORNIA*

HANIF GULMAHAMAD

Terminix International,¹ Rancho Cucamonga, California 91730

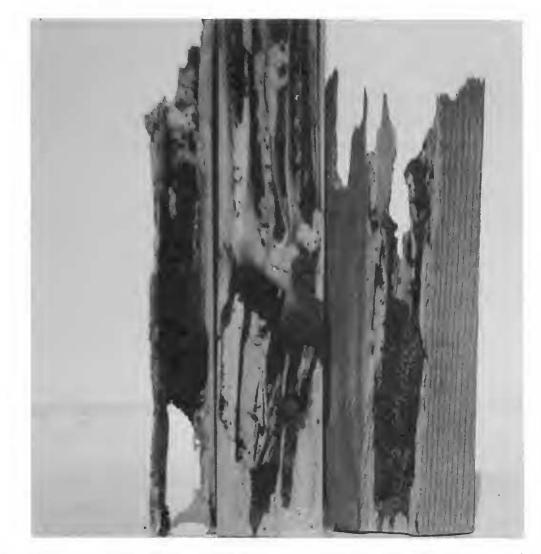
The attic inspection revealed substantial damage to several ceiling joists. A total of about ten to fifteen ceiling joists exhibited some damage. Vertical and horizontal pellet tubes of varying lengths were found on the ceiling joists. Many of the vertical pellet tubes had rings of pellets around them which had been expelled by the termites. The expelled pellets were loose, friable, and dark brown in color. The damage caused by this termite in construction grade lumber is similar to that caused by subterranean termites in that the tunnels followed the grain of the wood. Pellets were readily evident in these tunnels. Most of these pellets were glued together and thus were not as loose and friable as those produced by termites seldom broke through to the exterior. They left a thin layer of wood on the outside which offered them protection from the elements and their natural enemies. When the rolled insulation between the damaged ceiling joists was lifted, damage to the paper backing of the insulation was evident in several areas. Piles of pellets were also found adjacent to the ceiling joists near the insulation.

Probing of the infested joists revealed all stages of nymphs and several soldiers. The damage to the ceiling joists was so severe that the termite inspector expressed great reluctance to step on them because he feared that he might fall through the ceiling. Portions of some of these ceiling joists were so damaged that large chunks of wood could be removed with one's bare hands. Figure 1 shows three pieces of wood which were taken from damaged ceiling joists of the infested property at Cathedral City. What appeared to be mud tubes in these samples are really pellets

Figure 1. Portions of ceiling joists showing desert dampwood termite damage with fecal pellets glued together in the tunnels.

The exterior walls of this structure were covered with stucco which extended below the exterior grade level. It appears that *P. simplicicornis* was able to bridge the gap between the soil and wood members in the wall by constructing pellet tubes behind the stucco. Although a recommendation was made to open the exterior wall adjacent to the interior infested area for further inspection, the homeowner was not receptive to this suggestion. Based on the extent of the damage found in the ceiling joists, it is my belief that possible hidden damage exists in the adjacent wall.

At this time, I am not sure that the infestation of the desert dampwood termite described in this paper can be controlled by simply applying a termiticide to the soil. If this property is ever treated to control this infestation, it would be interesting to cut these termites off at soil level with a termiticide soil barrier and then monitor their survival in the ceiling joists.
